Upper Lillooet Hydro Project

Weekly Environmental Monitoring Report #4

Reporting Period: October 6th – October 12th, 2013

Lillooet River Forest Service Road (FSR) realignment and Transmission Line Clearing (Seg. 1 & 2)

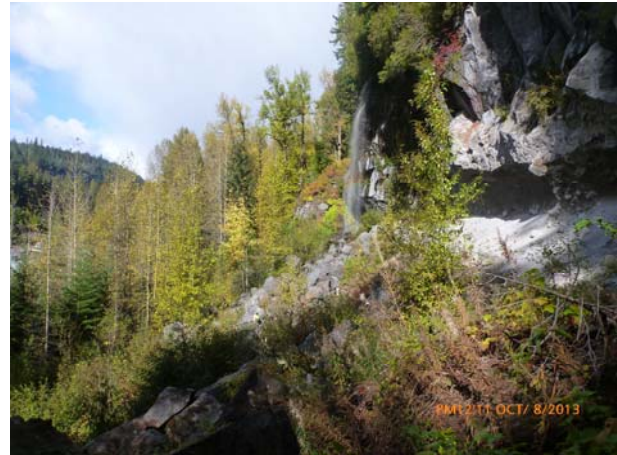
Photo 4. Looking towards the waterfall above first watercourse crossing along the trail alignment. (Oct 8, 2013).

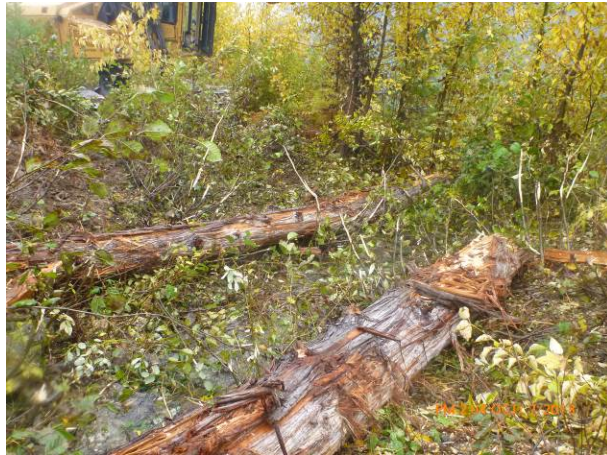
- Log loader and skidder were active within Class 1 Grizzly Bear forage habitat (poles 1 - 4.5).
- Feller buncher clearing progressed to pole 37.5 this week. Temporary crossings were completed according to DFO operational statement to access previously decommissioned roads. All streams were crossed by placing logs on the stream banks and walking the tracked machine over the logs while ensuring no impact to the channel substrates or banks. The environmental monitor was present for all stream crossings and for placement of logs on the stream banks. No WQ or stability concerns were observed. (Photo 5).

Photo 5. One example of a temporary crossing installed by the feller buncher to cross an open channel without impacting the stream banks or substrate (Oct. 7, 2013).

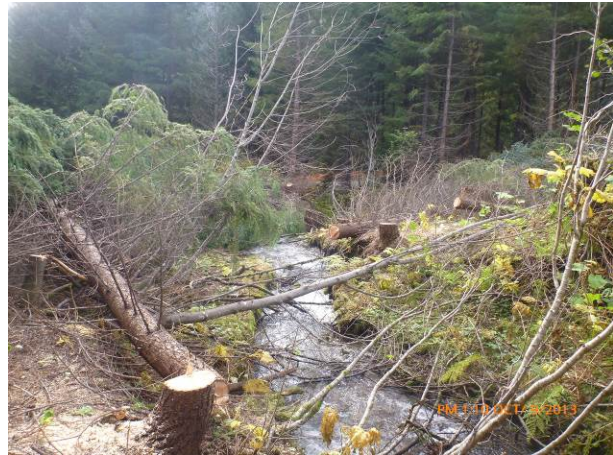
- Hand falling within the Stream 9 RVMA was monitored on Oct. 9. No environmental concerns were noted (Photo 6).

Photo 6. Conditions within stream 9 RVMA following hand clearing. No trees were felled into the watercourse. (Oct. 9, 2013).
