Upper Lillooet Hydro Project

Weekly Environmental Monitoring Report #5

Reporting Period: October 13th – October 19th, 2013

Lillooet River Forest Service Road (FSR) realignment and Transmission Line Clearing (Seg. 1 & 2)

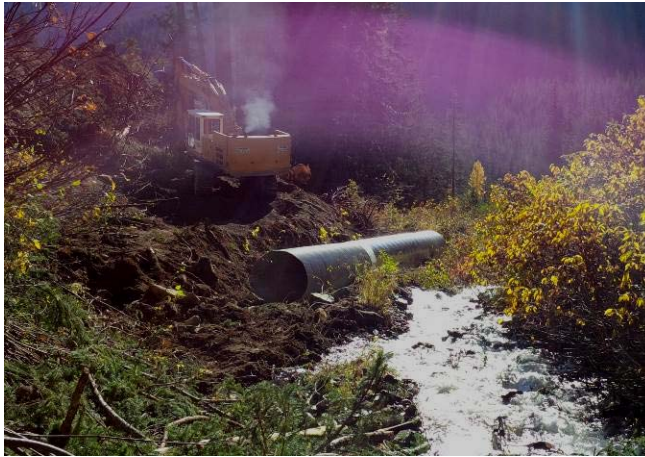
- Culvert installation (non-fish bearing stream) began at Stn. 1+430 on October 16th and was completed the following day (Oct. 17th). The initial works involved the installation of a small coffer dam (conducted by hand where possible), to direct flows to the right bank of the watercourse, outside of the work area (Photo 1). Once rocks were placed sufficiently to dewater the work area, SES conducted a precautionary Coastal Tailed Frog survey. No tadpoles or adults were observed. Once the survey was completed, the cofferdam was reinforced with native material, and bedding material was placed in preparation for culvert installation. WQ was routinely measured by the IEM, and a temporary exceedance of BCAWQG (<25 minutes; 10:10 - 10:35am) was observed during the initial placement of bedding material.

Photo 1. Culvert installation and cofferdam at Stn. 1+430 (Oct 16, 2013).

Following the installation of bedding material, culvert placement and inlet armouring, hydraulic reconnection was attempted as the cofferdam was removed, directing water through the newly installed culvert. Water began to enter the culvert, creating a temporary exceedance of BCAWQG (<25 minutes; 11:30 - 11:55am) as a result of excavation. Once the cofferdam was fully extended to the right bank and all flows were connected through the culvert, sudden undermining of the culvert bedding occurred when large boulder armouring the base of the culvert inlet was dislodged creating a turbid event. Emergency instream works ensued to breach the right side of the cofferdam and direct flows back into the pre-existing channel, while at the same time the left bank cofferdam was reinstated to isolate the active works area. Once this creek was successfully diverted back to the right bank, works were postponed until the following day. During this event WQ remained in exceedance of BCAWQG for approximately one hour.

Culvert installation resumed on October 17th, 2013. The bedding material, culvert armouring, and culvert backfilling were completed in the dry on the left portion of the channel. Once the backfilling and armouring of the culvert were completed water was directed through the newly installed culvert. Water quality was monitored during cofferdam removal which resulted in a temporary exceedance of BCWQG (<30 minutes; 9:45 – 10:15 am). Backfilling of the remaining portion was completed after the watercourse was successfully diverted through the new culvert. No further water quality exceedances were noted. All water quality results are presented in the table below.

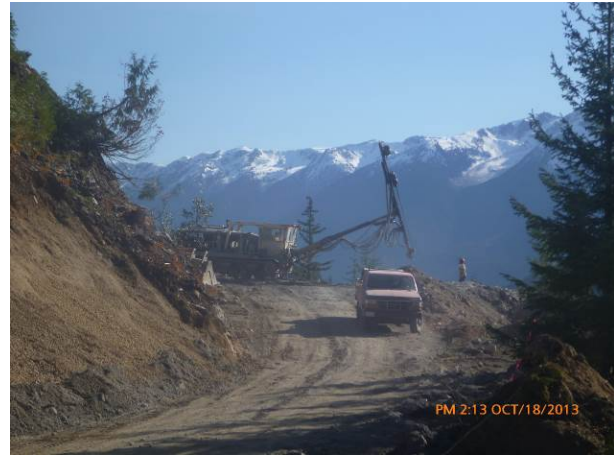
- Continued clearing, bulk excavation and road base construction on west side of Truckwash Creek from FSR realignment Stn 2+200m – 1+950m. Drilling began on October 15, 2013 and the first blast occurred on October 17, 2013 (Photo 2) and continued for the remainder of the reporting period.
- Construction at the east heading, including bulk excavation and the installation of a 1600mm CSP culvert (Stn. 1+430).
- Installation of a visual barrier along the perimeter of the stream located at the intersection of the east Truckwash Creek work heading and the current FSR alignment was completed during this reporting period. The visual barrier was installed as recommended in the previous monitoring report (WEMR #4).
- Hand falling trees within 500m of Grizzly Bear Class 1 habitat (suitable fall forage; ULL-GB05) occurred on October 19th, 2013. Clearing limits were minimized.

Photo 2. Drilling activities at the west heading of the Truckwash Creek FSR realignment (Oct 18, 2013).

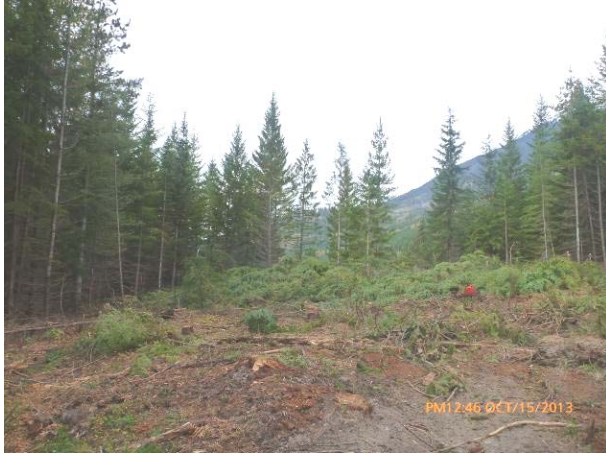
- No Feller buncher clearing activities occurred during this reporting period.
- Hand falling within the RVMA areas associated with Boulder Creek and Streams 30A, 33A, and 34A occurred this week (Photo 3). Vegetable based bar oil was used in the chainsaws operating within 15m of a watercourse (Photo 4).
- Hand falling occurred on the steep slope above the Lillooet River FSR near 41km for the clear span section between poles 5 & 6. This work required fallers to be harnessed and secured with ropes and temporary road closures in this section of the FSR. No logs or debris entered the Lillooet River which is located adjacent to the FSR in this section.

Photo 3. Results of hand falling within the 30m Boulder Creek Coastal Tailed Frog habitat buffer. The remaining trees will be topped (Oct. 15, 2013).

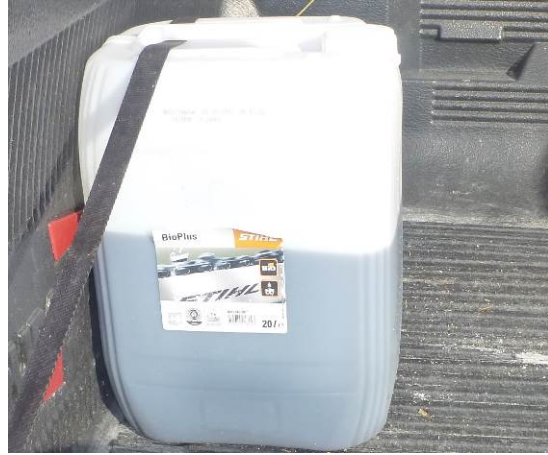
Photo 4. BioPlus vegetable based chainsaw bar oil used when hand falling with RVMA areas. (Oct. 15, 2013).
