Upper Lillooet Hydro Project

Weekly Environmental Monitoring Report #18

Reporting Period: April 20th – April 26th, 2014

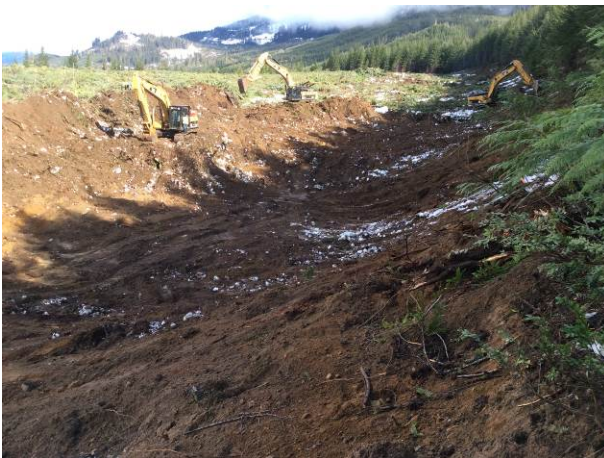
- Hand-falling of trees within the Construction Camp (middle) location (*EAC amendment #3*) was completed this week. Boundary flagging was visible and all hand falling remained within the clearing limits. Sorting/stockpiling of merchantable timber began following a pre-work activity meeting (April 23rd) and prior to stripping and grubbing activities.

Photo 1. Stripping and grubbing of the Construction Camp work area. (April 25, 2013).

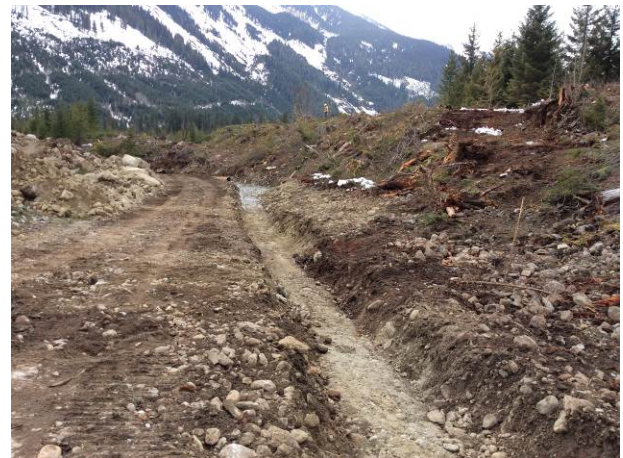
- A pre-work meeting was held on April 24th to review the work plan. Work began by installing road side drainage ditches following the methods described in the work plan. All site water was directed to newly installed ditches and conveyed through temporary road culverts. All powerhouse site drainages infiltrate to ground prior to connecting to Boulder Creek or its tributaries.

Photo 2. Road side drainage installation at the BDRHEF powerhouse location. (April 26, 2013).

Surface water management on the FSR should continue throughout the spring melt period to protect water quality in adjacent watercourses by directing sediment laden water to adjacent vegetated areas and/or road side ditches.
