# Upper Lillooet Hydro Project

## Weekly Environmental Monitoring Report #29

Reporting Period: July 6<sup>th</sup> – July 12<sup>th</sup>, 2014

Upper Lillooet River Hydroelectric Facility (Water File No. 2002561, Water licence No. C130613),  
Boulder Creek Hydroelectric Facility (Water File No. 2003049, Water licence No. C129969) &  
Transmission Line (TX Line)

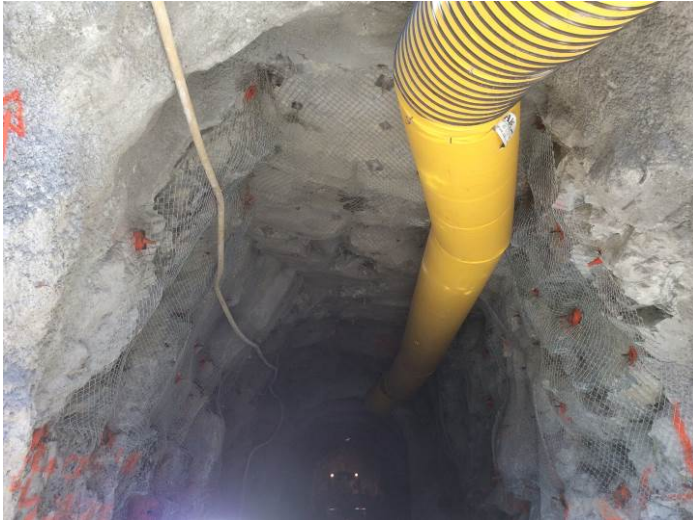
- Tunneling activities (including: drilling, blasting, excavation, rock bolts and shotcrete/mesh installation) continued (Photo 1).
- The settling ponds installed during the previous monitoring period were effectively used to manage water from seepages encountered during tunnelling activities and to manage excess process water this week. No discharge from the sediment ponds occurred this week, therefore no water quality samples were collected. Once the powerhouse excavation begins these ponds will also be used to manage seepage from the base of the excavation in addition to the seepage/process water from the tunneling operations.

**Photo 1. Tunneling works at the tunnel portal entrance. (July 9, 2014).**

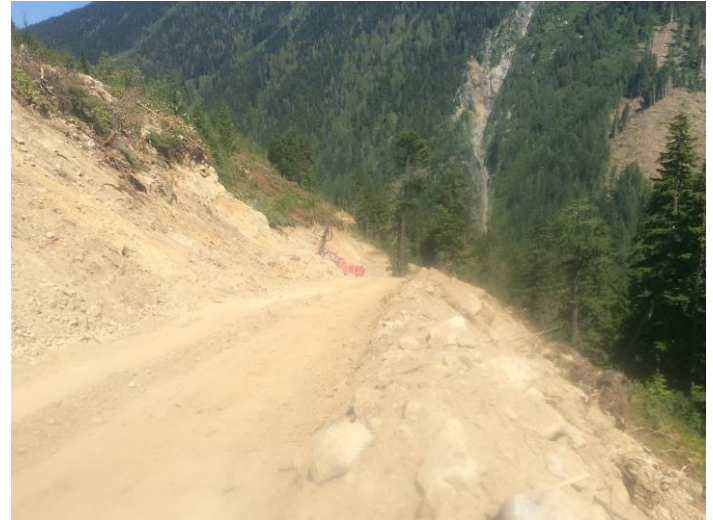
- Clearing of the road alignment continued this week, the remaining area along the road alignment to be cleared is within an active bird nest buffer and will only be cleared following confirmation from the contractor's QP.
- Following tree falling, construction of the new section of the access road continued for the first 200m during this reporting period (Photo 2).
- Blasting of bedrock within the road alignment was completed using revised blasting mitigations as the use of blast mats was not feasible due to the steepness of the terrain.

**Photo 2. Construction of the BDR intake access road. (July 11, 2014).**

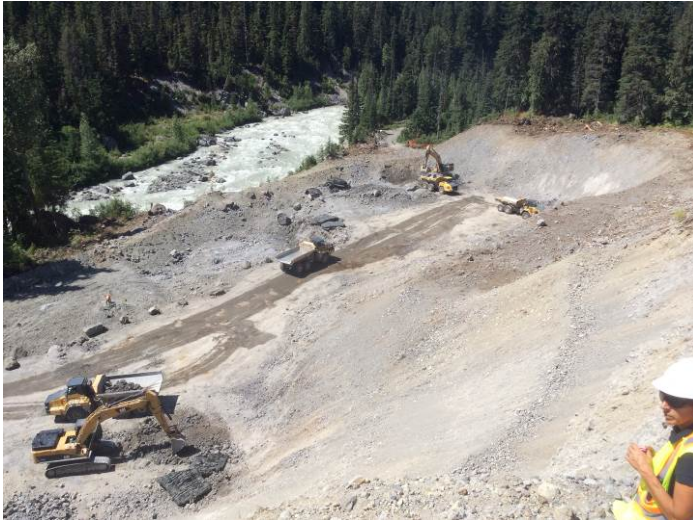
- Excavation at the ULRHEF powerhouse continued this week (Photo 3). The excavated material was dumped within the limits of the powerhouse spoil area and suitable material was separated and hauled to the crushing/screening plant located at the km 38 laydown. Blasting of exposed boulders occurred on July 6<sup>th</sup>-8<sup>th</sup>. Blast mats were used and instream acoustic pressure monitoring was performed. The blasts did not result in instream overpressure within the Lillooet River. No environmental concerns were noted.

**Photo 3. Excavation of the ULRHEF powerhouse footprint (July 9, 2014).**

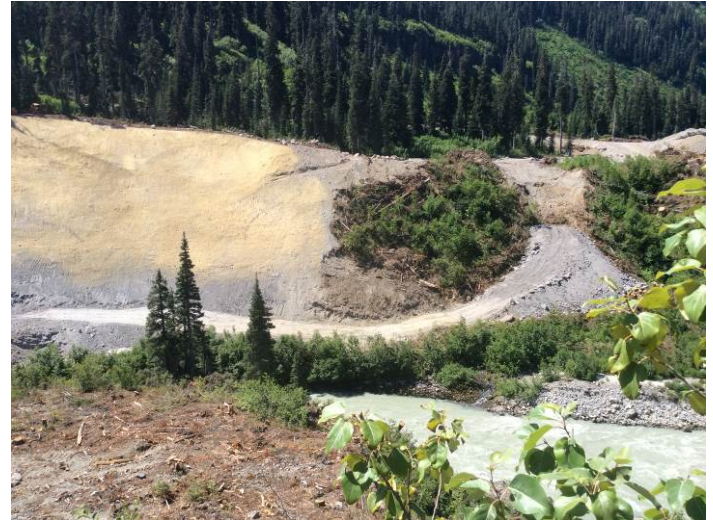
- Construction of a haul road to access the south spoil area from the diversion channel excavation commenced this week. The location and plan for the haul road was discussed onsite with the IEM prior to commencing construction of this temporary road. The haul road will eventually be used to access and remove the upstream diversion channel plug during the commissioning of the diversion channel (Photo 4)
- The hydro-seeding of the exposed cut-slopes does not appear to have successfully re-vegetated the slope. This slope may need to be hydro-seeded again once suitable weather conditions are forecast or other interim mitigation measures will need to be employed prior to the rainy season (e.g. poly sheeting, coco matting, etc.) (Photo 4).

**Photo 4. Construction underway for temporary haul road. Hydro-seeding has not successfully germinated at the ULRHEF intake diversion (July 9, 2014).**

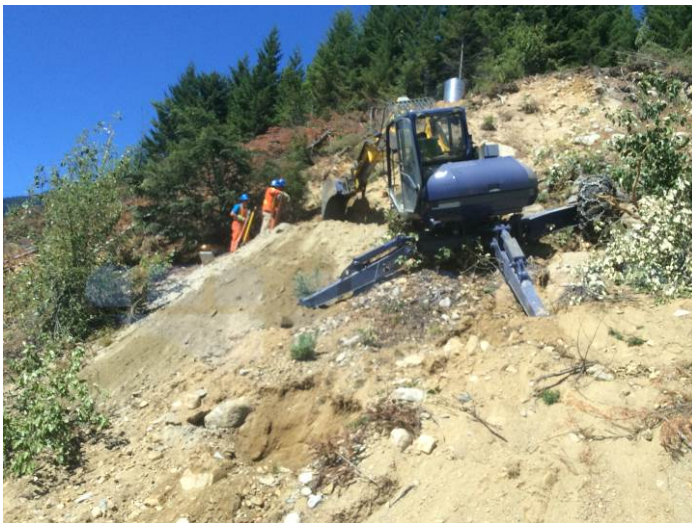
- Felled timber was removed from the steep slopes in Segment 1 (above 41km of the Lillooet River FSR) by helicopter. All merchantable timber was decked roadside and at 40.5km of the Lillooet River FSR.
- Pole installation and dressing continued in Segments 2 and began in Segment 5 this week. Temporary access tracks to the pole locations were constructed and pole foundations were installed on steep slopes in Segment 2 using a specialized spider hoe excavator (Photo 5).
- Clearing occurred in Segment 3, 4, and 10 following the completion of AMBNS.
- Access roads were upgraded/constructed in Segments 7, 9, & 10 this week (Photo 6).

Photo 5. Pole foundation installation in Segment 2 with an excavator capable of working on steep slopes (July 9, 2014).

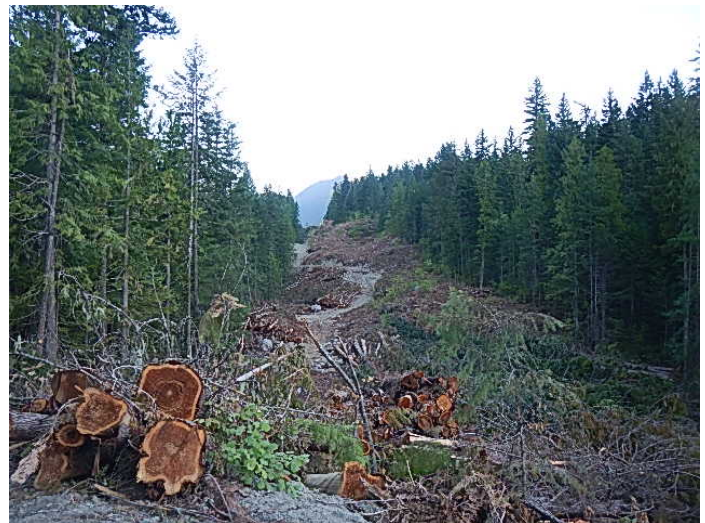
Photo 6. Clearing and access track construction in Segment 7 (July 11, 2014).
