Upper Lillooet Hydro Project

Weekly Environmental Monitoring Report #31

Reporting Period: July 20th – July 26th, 2014

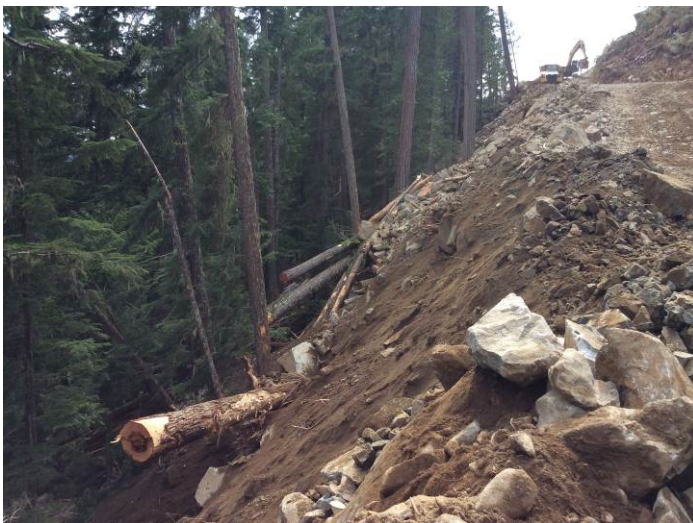
- The following environmental concerns regarding works at the BDR HEF intake access road were discussed on July 22nd, 2014 and CRT-ebc committed to addressing the concerns as outlined:

1. Culvert installation (identified as a Hold Point in the work plan) was completed without IEM notification or presence. An EIR is being prepared by CRT-ebc (ULR#16; EIR#010).

2. Damage to standing timber, impacts outside of the clearing boundary, and use of felled timber in the base of road fill was visually confirmed in the field. CRT-ebc will assess the impacts outside of the clearing boundary and commission a road stability and slope stability assessment of the current road conditions by the road design engineer (Hedberg) (ULR#17; EIR#011).

3. Blast rock has been used in the road fill and has not been hauled pending the results of ARD sampling. CRT-ebc has indicated at this material will remain in place until sampling results confirm if the rock is PAG or non-PAG.

Photo 1. Boulder Intake Access road construction practices that did not conform to the work plan and resulted in a Stop Work Order by the Owner and IE. (July 21, 2014).

All items of the IE issued Stop Work Order for the Boulder Creek intake access road and crane pad construction must be addressed in a timely manner to the satisfaction of the IE prior to resuming works.

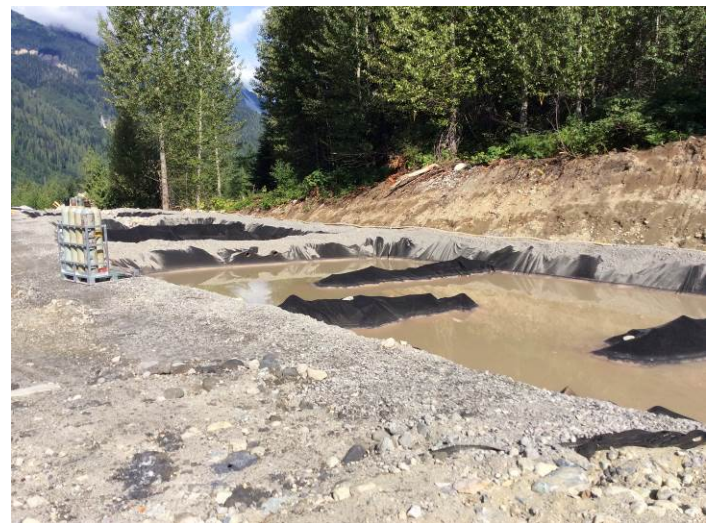
- Tunneling activities encountered seepage water during this monitoring period. The water flowed out of the tunnel, and was collected at the portal tunnel entrance in a sump. The water was then pumped from the sump to the oil/water separator, pH adjustment holding tank, and settlement ponds for treatment. The pH was monitored daily by the contractor and a CO₂ diffuser was used as necessary to ensure pH was within acceptable surface water quality guidelines (pH 6.5 – 9). No discharge from the treatment ponds occurred during this reporting period; therefore the IEM did not collect water quality results (Photo 2).

Photo 2. Dewatering of seepage from the tunneling activities was performed this week but the water has not yet reached the second treatment pond (July 19, 2014).

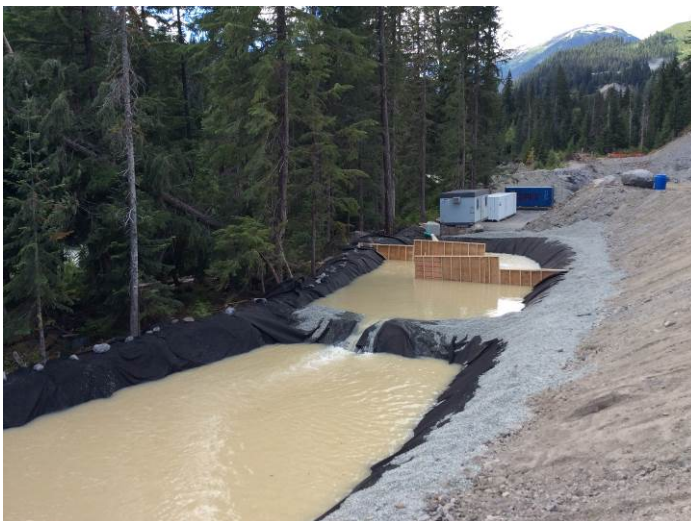
- Excavation at the ULRHEF powerhouse continued this week. The excavated material was dumped within the limits of the powerhouse spoil area and suitable material was separated and hauled to the crushing/screening plant located near 38km of the Lillooet River FSR.
- Sediment ponds were constructed to treat seepage water from within the powerhouse excavation (Photo 3).

Photo 3. Sediment ponds constructed to for the treatment of dewatering the ULRHEF powerhouse excavation (July 25, 2014).

- Dewatering of the powerhouse excavation into the sediment ponds will be monitored daily and water quality will be recorded should the discharge to vegetation reach the Lillooet River.
- The IEM collected water quality samples of run-off emanating from the PAG stockpile located at the Truckwash west heading and submitted water quality samples for lab analysis on July 24th. Once sampling results are received from the lab they will be appended to the weekly report. Sampling will continue on a monthly basis according to the ARD/ML management plan.

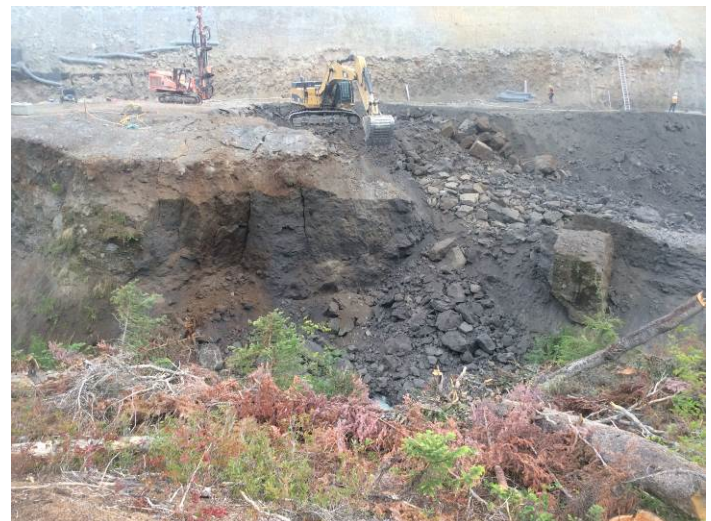
- On July 23rd, 2014 the IEM observed some rock fall entering the Lillooet River during excavation of a blast completed that morning (Photo 4). In discussion with CRT-ebc and Innergex, the IEM confirmed that they observed that all attempts to minimize rocks from entering the Upper Lillooet River were made during excavation works. The IEM will have a monitor onsite full time for all future blasts and excavation activities at ULR intake diversion channel to ensure all efforts to prevent rocks from entering the Lillooet River are made and to document approximate quantities when rocks to enter the River. The IEM recognizes that large rocks are not a deleterious

substance and that rock entering the river at this location is unlikely to cause serious harm to fish given the marginal fish habitat present at this location due to the water velocity within the rock canyon.

Photo 4. Excavation of blasted rock at the ULR intake diversion channel. Minor amounts of rock fell into the Lillooet River during monitoring of the works. (July 23, 2014).

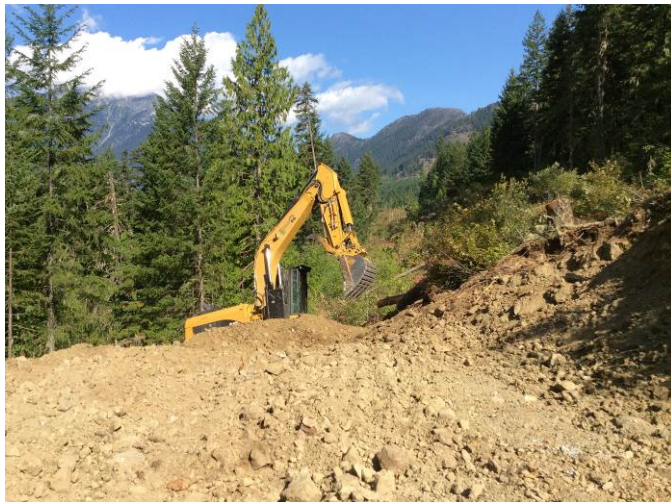
- Clearing occurred in Segment 4, within the Stream 80A RVMA and within CTF 100m buffer area in Segment 7, following the completion of AMBNS.
- Access roads were upgraded/constructed in Segments 7 & 10 this week (Photo 5).

Photo 5. Road construction in Segment 7 (July 22, 2014).

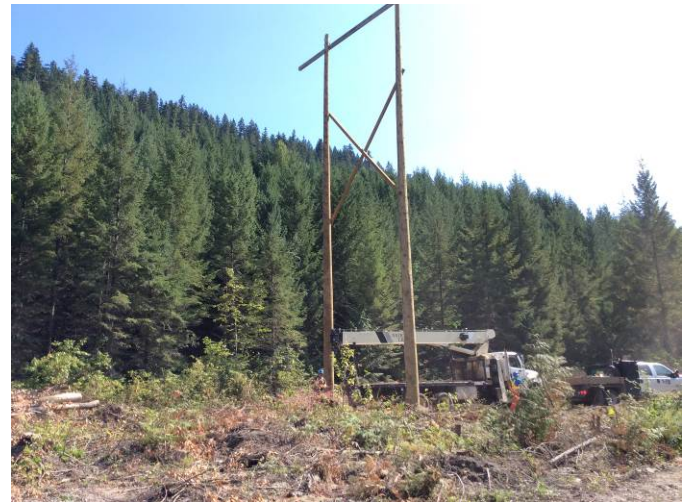
- Pole installation and dressing continued in Segment 4 & 5 this week (Photo 6).

Photo 6. Poles installation in Segment 4 (July 19, 2014).
