Upper Lillooet Hydro Project

Weekly Environmental Monitoring Report #33

Reporting Period: August 3rd – August 9th, 2014

Upper Lillooet River Hydroelectric Facility (Water File No. 2002561, Water licence No. C130613), Boulder Creek Hydroelectric Facility (Water File No. 2003049, Water licence No. C129969) & Transmission Line (TX Line)

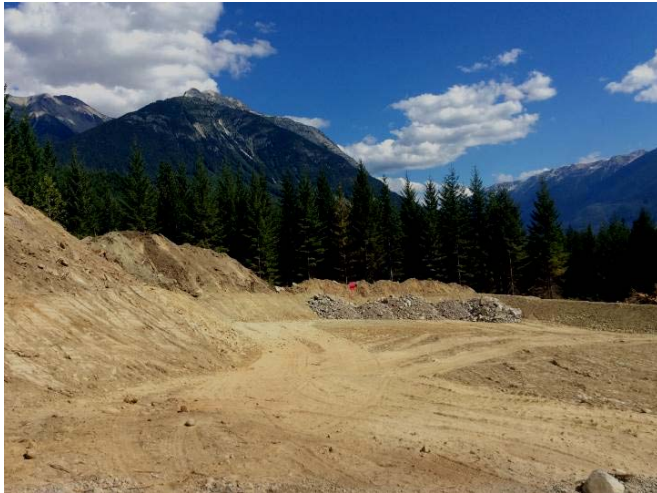
Photo 1. Preparing BDR-4 as a temporary storage area for PAG generated from the Boulder Intake access road construction. This area will be used once works resume following the removal of the Stop Work Order (August 6, 2014).

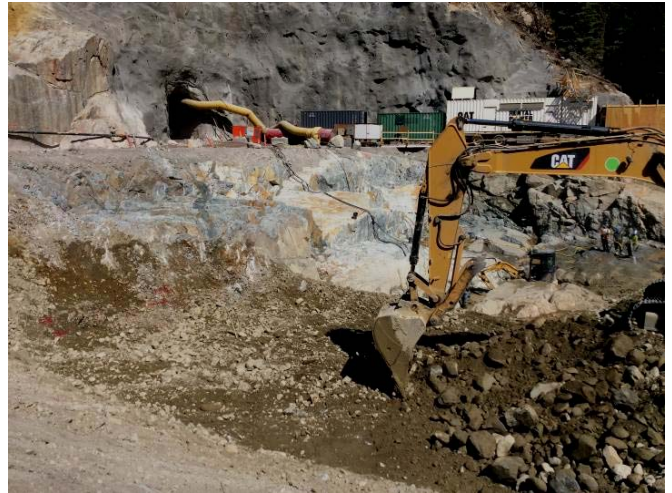
- The powerhouse excavation continued this week. Seepage water from the excavation seepage is being directed to a central sump and pumped to the sediment ponds currently being used to manage seepage/process water from the tunneling operations (Photo 2).

Photo 2. Dewatering of seepage from within the powerhouse excavation was pumped to the sediment ponds. Water has not yet reached the second treatment pond (August 9, 2014).

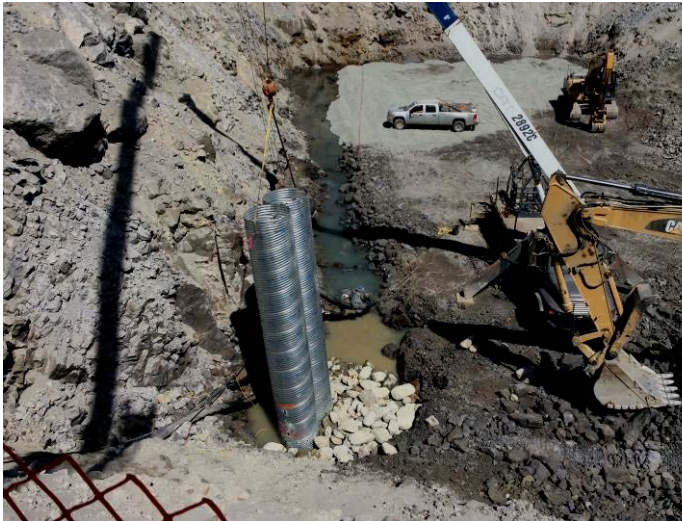
Photo 3. Installing sumps within the ULR powerhouse excavation. Water is running as clean as the Lillooet River but will continue to be directed to the treatment ponds (August 7, 2014).

- Dewatering of the powerhouse excavation into the sediment ponds will be monitored daily and water quality will be recorded daily when the discharge to vegetation reaches the Lillooet River.

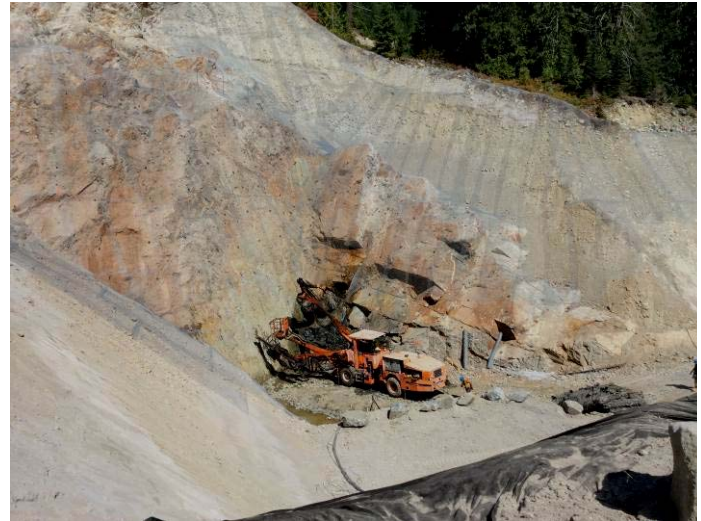
- A gravity feed water extraction system was used for drilling activities according to the conditions of the Short Term Water Use Approval (No.A2006123) (Photo 4).

Photo 4. Drilling activities at the ULR downstream portal. (August 6, 2014).

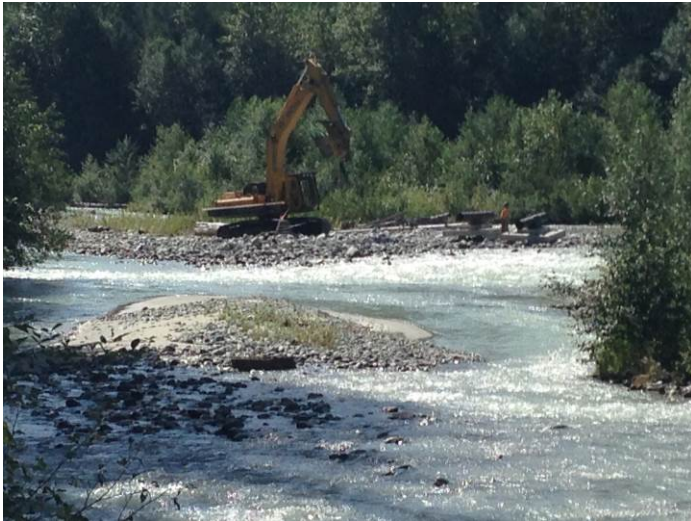
- The wet crossing of an excavator across the Ryan River was completed following review of the work plan and an according to BMPs during the instream works window. The excavator operator successfully minimized impacts to the channel substrates by not altering his direction of travel while crossing the wetted portions of the channel. Water quality was monitored full time during the wet crossing and no measureable exceedances were observed (See WQ results below).

Photo 5. Wet crossing of the Ryan River. (August 9, 2014).

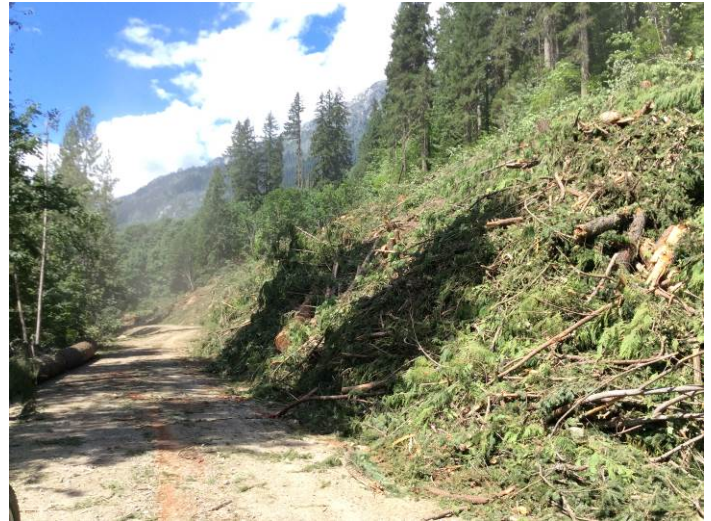
- Pole installation and foundation works continued in Segment 4 & 5 this week.
- Hand clearing occurred in Segments 5, 6 & 7, (Photo 6).
- Access roads were upgraded/constructed in Segments 7 & 10 this week. Works in Segment 10 included widening of the approach to the Ryan River Bridge, which involved drilling and blasting within 30m of the Ryan River (Photo 5). The IEM was onsite and conducted instream acoustic pressure monitoring during blasting activities on August 5th. An instream acoustic overpressure of 78.3kPa was recorded during the blast; crews were advised that future blasts at the location would require increased mitigation measure to prevent additional instream over pressures. No fish mortality was observed as a result of the blast and no serious harm to fish to suspected to have occurred.

Photo 6. Results of hand clearing in Segment 5 (August 6, 2014).
