Upper Lillooet Hydro Project

Weekly Environmental Monitoring Report #34

Reporting Period: August 10th – August 16th, 2014

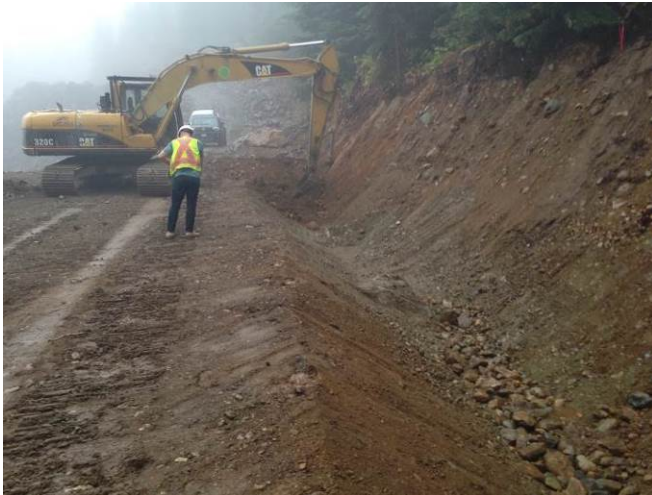
Photo 1. Ditching and slope stabilization along the new Boulder Intake access road following prescription outlined in the work plan. (August 15, 2014).

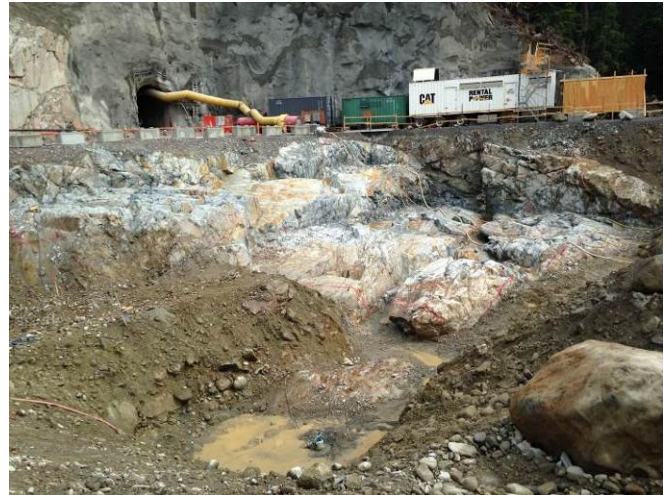
- The settling ponds were effectively used to manage water from seepages encountered during tunnelling activities and to manage excess process water this week. No discharge from the sediment ponds occurred this week; therefore, no WQ samples were collected.
- The powerhouse excavation was completed and concrete form works began in preparation for the mud slab concrete pour, following a pre-activity meeting on August 16th. Seepage water from the excavation seepage is being directed to a central sump and pumped to the sediment ponds currently being used to manage seepage/process water from the tunneling operations (Photo 2).

Photo 2. Dewatering of seepage from within the powerhouse excavation was pumped to the sediment ponds. Water has not yet reached the second treatment pond (August 15, 2014).

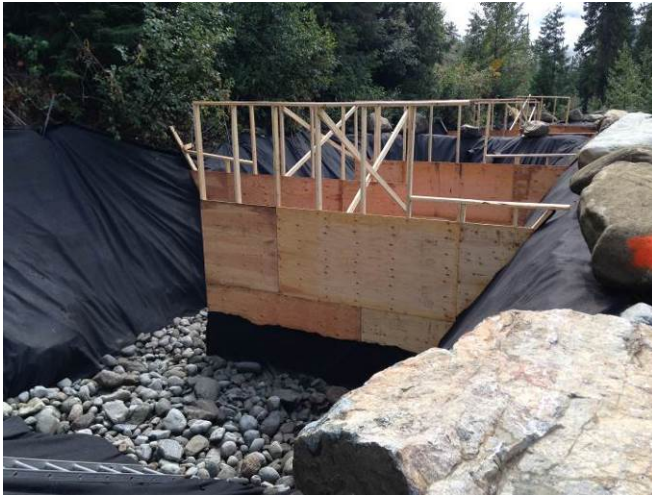
- Excavation is complete and work is on hold pending the ULR powerhouse concrete LTC.
- Sediment ponds were used to treat seepage water from within the powerhouse excavation (Photo 3). Water from the ponds discharged to vegetation prior to reaching the Lillooet River. Water quality was taken upstream and downstream of the discharge point (within the mixing zone) daily when water reached the Lillooet River. No WQ concerns were noted (see Results below)

Photo 3. Constructed sediment ponds to be used for treatment of seepage water emanating from the ULRHEF downstream tunnel portal. (August 15, 2014).

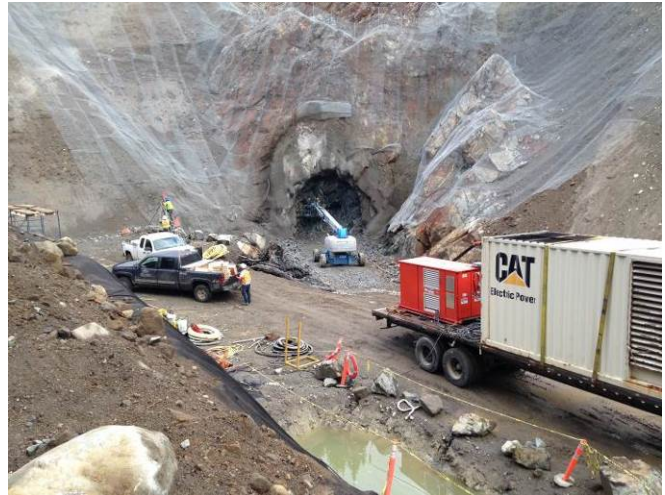
- A gravity feed water extraction system was used for drilling activities according to the conditions of the Short Term Water Use Approval (No.A2006123) (Photo 4).

Photo 4. Tunnel stabilization activities at the ULR downstream portal. (August 15, 2014).

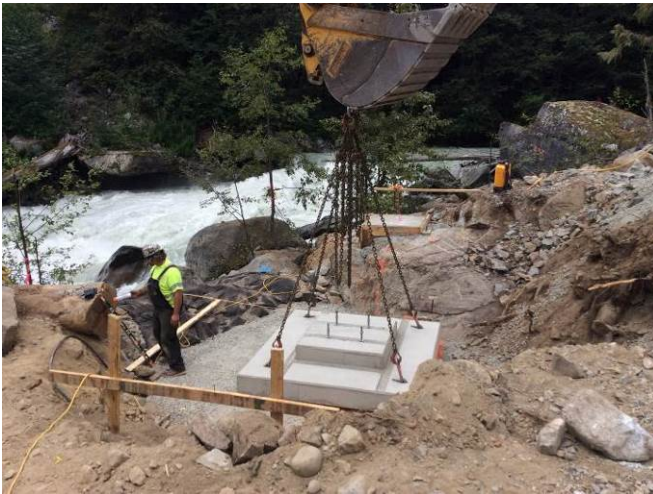
Photo 5. Placement of Ryan River bridge footing (August 12, 2014).

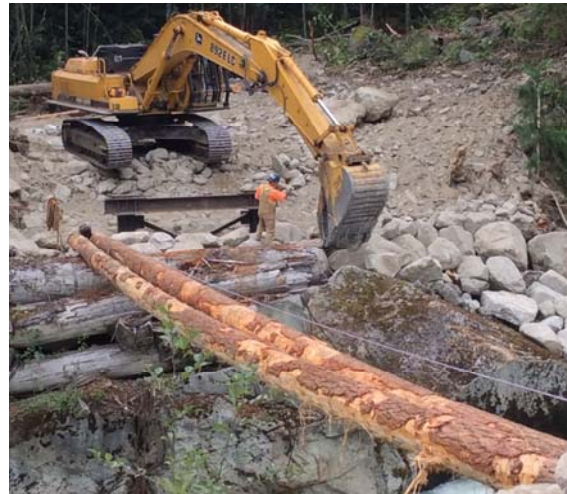
Photo 6. Riprap placement adjacent to the Ryan River (August 14, 2014).
