Upper Lillooet Hydro Project

Weekly Environmental Monitoring Report #35

Reporting Period: August 17th – August 23rd, 2014

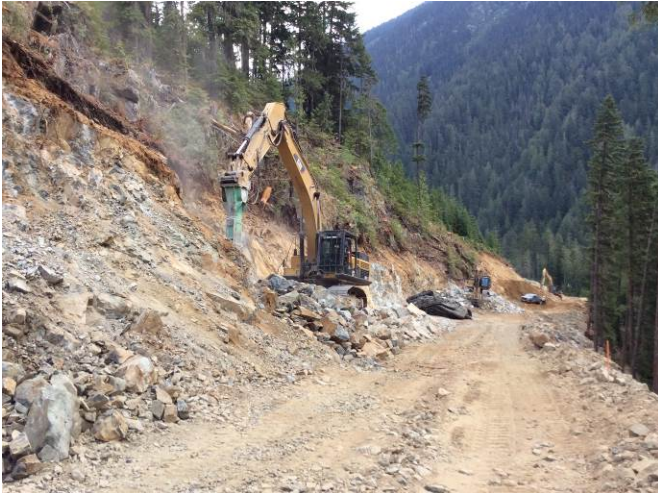
- Road construction and repair work was completed according to methods outlined in the work plan and continued under IEM supervision this week (Photo 1). The IEM can confirm that all excavator operators performing the repair and stabilization works demonstrated due care when operating on and adjacent to steep slopes. To the extent possible operators prevented rocks and debris from rolling downhill during the repair works to prevent additional impacts to standing timber outside of the approved OLTC boundaries.

Photo 1. Completing slope stabilization along the new Boulder Intake access road following prescription outlined in the work plan. (August 21, 2014).

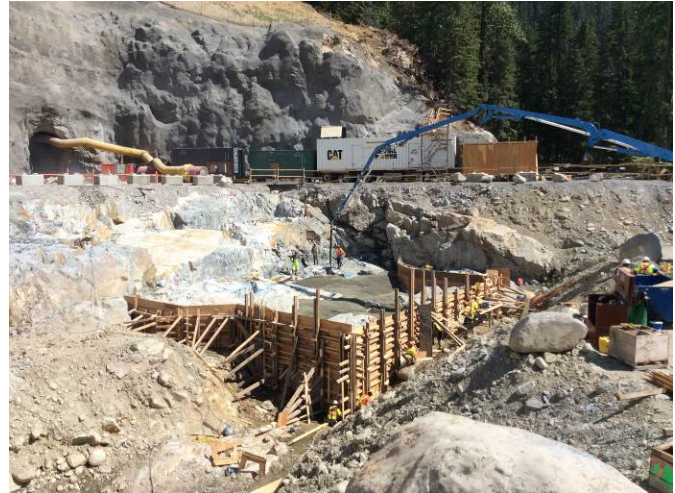
- Tunneling activities (including: drilling, blasting, excavation, rock bolts and shotcrete/mesh installation) continued.
- The settling ponds were effectively used to manage water from seepages encountered during tunnelling activities and to manage excess process water this week. No discharge from the sediment ponds occurred this week; therefore, no WQ samples were collected.
- Concrete form works were inspected and a pre-work meeting was conducted on August 20th prior to the concrete mud slab pour at the BDRHEF powerhouse. Seepage water from the excavation and water coming in contact with concrete is being directed to a central sump and is pH adjusted prior to discharging to the sediment ponds currently being used to manage seepage/process water from the tunneling operations (Photo 2).

Photo 2. Concrete mud slab pour. Dewatering of seepage from within the forms was pumped to the sediment ponds. Water has not yet reached the third treatment pond (August 20, 2014).

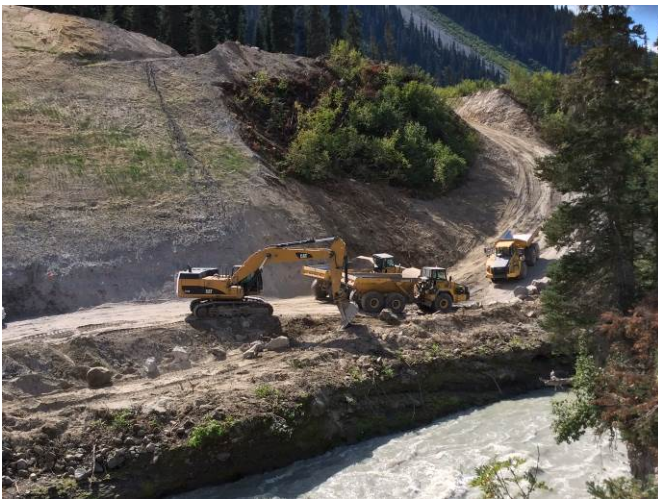
- Works associated with the intake diversion channel occurred daily as the landslide risk remained within acceptable limits during this reporting period (Photo 3). Works included drilling, blasting, excavation, and slope stabilization (shotcrete application). Night shift works at the intake began on August 20th and the IEM was onsite to monitor when excavation and construction activities took place within 30m of the Lillooet River.

Photo 3. ULRHEF intake diversion channel excavation adjacent to the Lillooet River. (August 21, 2014).

The installation of ESC measures (including hydro-seeding, protection with poly-sheeting) should be performed on all cut-slopes at risk of eroding during rain events. In particular, the steep cut slopes at the ULRHEF diversion channel, ULRHEF downstream tunnel portal, ULRHEF powerhouse, and BDRHEF tunnel portal, are all at risk of developing rills during heavy rain events. Where these cut slopes are permanent a permanent solution is recommended.

The IEM recommends that a shallow interception ditch or swale be installed at the top of the ULRHEF intake diversion channel cut-slope. This ditch/swale should be installed to direct the surface runoff towards the adjacent forested area for infiltration, and prevent it from flowing over the slope. The intent is to prevent further generation of rills that have already begun to develop.

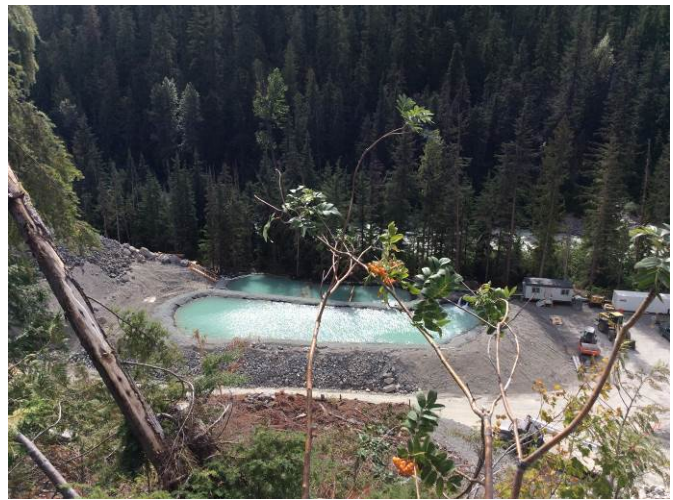
- Sediment ponds were used to treat seepage water from within the powerhouse excavation (Photo 4). Water from the ponds discharged to vegetation prior to reaching the Lillooet River. Further to routine weekly WQ sampling (see below), turbidity was visually monitored during periodic component visits by the IEM both upstream and downstream of the discharge point on the Lillooet River. Water entering the Lillooet River remained visually less turbid than the River itself during each inspection and works within the powerhouse excavation did not come in contact with the seepage water during this reporting period. No WQ concerns were noted during this reporting period and moving forward, WQ (other than routine), will only be conducted if the construction activities occurring within the powerhouse excavation (now completed to grade) occur that have the potential to affect WQ.

Photo 4. Conditions of the ULR HEF powerhouse sediment ponds. (August 20, 2014).

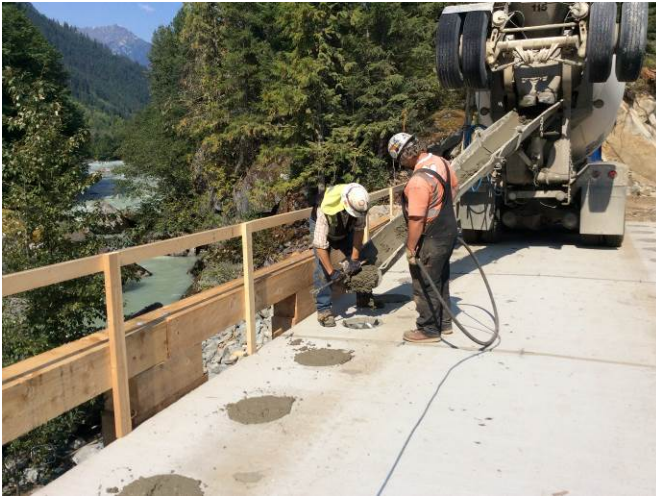
- Access roads were upgraded/constructed in Segments 10 this week. The Ryan River precast decking was installed and grouted during this reporting period following IEM inspection of the form work (Photo 5). No environmental concerns were noted during the grouting activities or during other environmental monitoring inspections.

Photo 5. Grouting of Ryan River bridge deck panels (August 22, 2014).

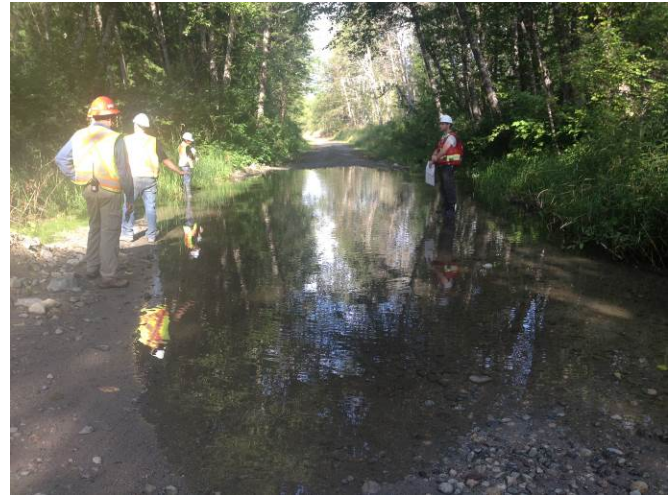
Photo 6. Flooded section of the South Lillooet River FSR containing fish. (August 20, 2014).
